Rapid Retrofit and Strengthening of Bridge Components

Report Number: KTC-19-07/SPR13-465-1F

Research Report
KTC-19-07/SPR13-465-1F

July 2019

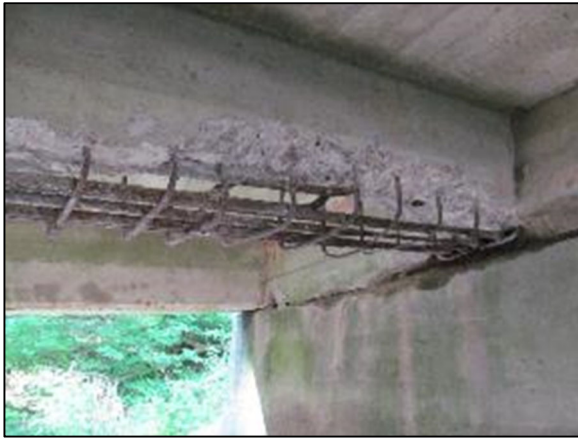
Fig. 7. Repair Process of KY 55 over Major Run Creek

KYTC District 06 bridge maintenance personnel carried out the retrofit in June 2013. Initially, all loose concrete was removed from cracked regions of the girders. Crew members used pneumatic chipping hammers to remove the material and expose at least one inch of non-corroded reinforcing steel (Fig. 7(a)). The steel was then sandblasted to remove rust, and a zinc primer was applied with a brush after wiping it with a solvent (Fig. 7(b), (c)). Wooden forms were erected to ensure the repair mortar cured appropriately to provide the original shape of the beam (Fig. 7(d)). The forms were removed once the repair mortar had cured. A mechanical grinder was used to remove any in-plane variations between the repair mortar and pre-existing concrete.

(a) Concrete removed to expose rebar

(c) Zinc primer brushed onto rebar

(d) Wood framework and repair mortar application

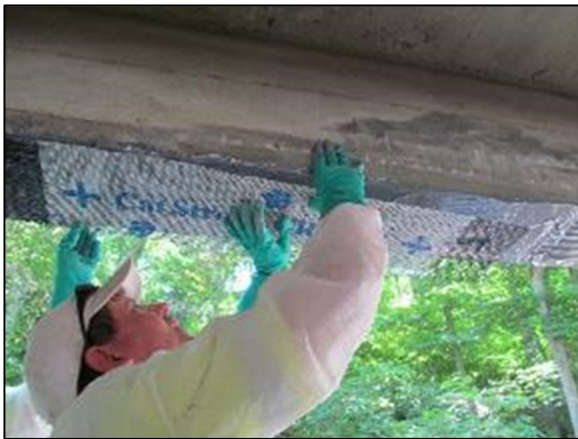
Fig. 8. CRP and TCF application on KY 55 over Majors Run Creek

A two-part epoxy was applied to the clean concrete and the CatStrong CRP 070 was placed over the epoxy and pressed into it by hand (Fig. 8(a)). This was carried out in a modular fashion, moving from one panel to the next. Each panel was connected to the next using the finger joint connection. Once rod panels were in place along the vertical and bottom faces of the girder, additional epoxy was applied over the finger joint area all the way to the top of the girders, and the CatStrong TCF 012 was placed over top of the CRP 070 using a dry layup process. All air pockets and irregularities were smoothed out of the fabric with laminating rollers (Fig. 8(b)). Fig. 9 depicts the bridge following the completed retrofit. The retrofit underwent periodic inspections in the three years following the construction — no defects were observed.

(a) CRP 070 applied with epoxy

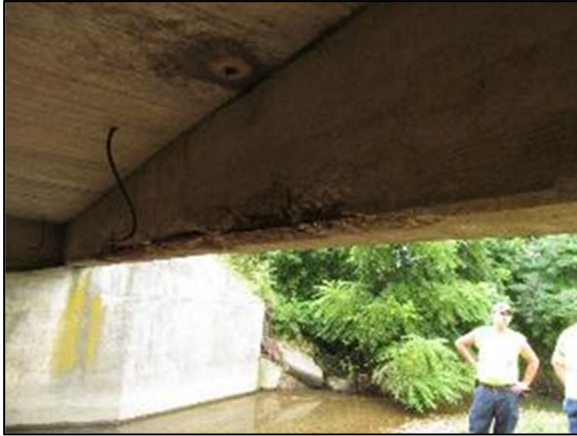
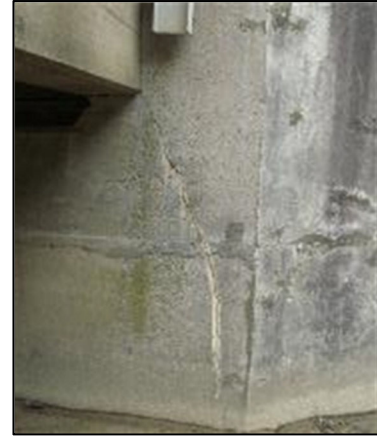
Fig. 12. Damage to concrete girders and abutment

The primary damage observed was spalled concrete and corroded reinforcement along the length of Girder G1 (Fig. 12(a)). In addition, two vertical cracks (Fig. 12(b)) were observed on the abutment walls.

(a) Damage to girder G1

(b) Damage to abutment wall

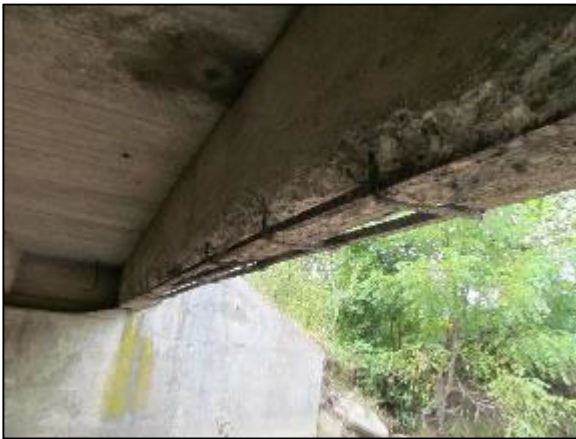
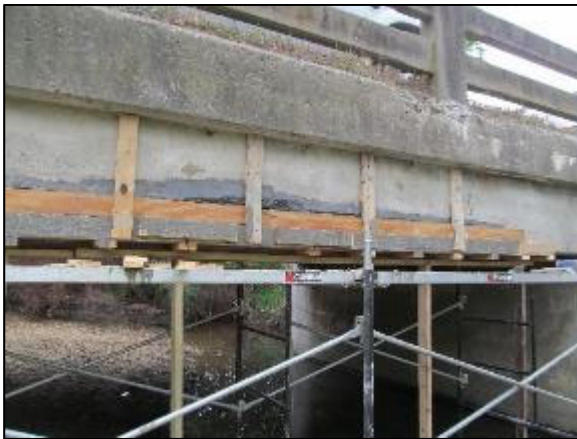
Fig. 14. Repair process of KY11 over Cat Creek

The retrofit was carried out by the KYTC District 10 Bridge Maintenance personnel in September 2013. Initially, all loose concrete was removed from the damaged regions of the exterior girder. Crew members used pneumatic chipping hammers to remove the material and expose at least one inch of non-corroded reinforcing steel (Fig. 14(a)). The steel was then sandblasted to remove rust, and a zinc primer was applied with a brush after wiping it with a solvent (Fig. 14(b)). Wooden forms were erected to ensure the repair mortar cured appropriately to provide the original shape of the beam (Fig. 14(c)). The forms were removed once the repair mortar had cured. A mechanical grinder was used to remove any in-plane variations between the repair mortar and pre-existing concrete.

(a) Concrete removed to expose rebar

(c) Wood formwork and repair mortar application

(d) Repair of abutment crack

Crack injection ports were mounted, and the exterior of the abutment cracks was covered using a trowel-grade epoxy (Fig. 14(d)). Following the exterior epoxy's curing period, a crack-injection

epoxy was introduced, starting from the bottom-most port and gravity fed in to the cracks. After the crack-injection epoxy had cured, the crack injection ports and excess epoxy over the cracks were ground off.

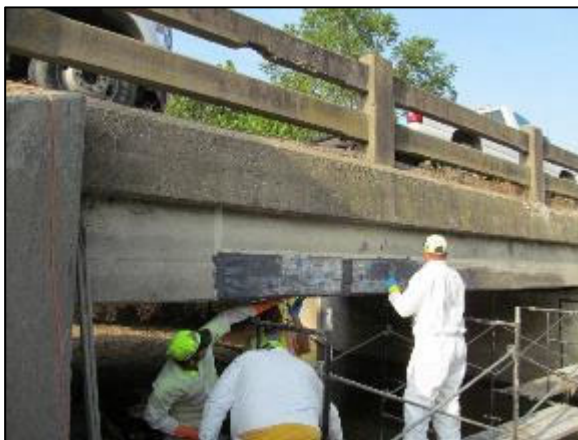
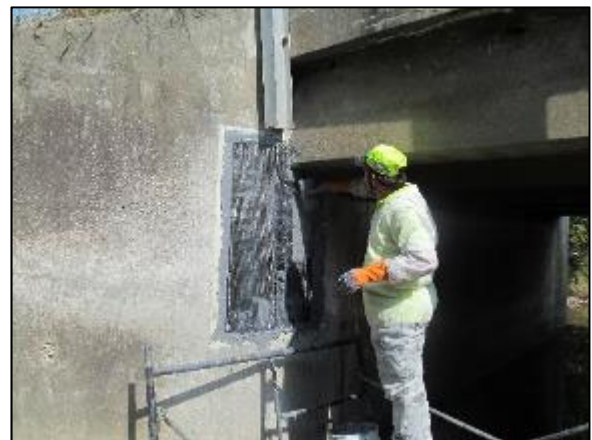
Fig. 15. CRP and TCF application on KY11 over Cat Creek

The same two-part epoxy used on the KY 55 bridge in KYTC District 06 was applied to the concrete; the CatStrong CRP 070 was placed over the epoxy and pressed into it by hand. This was carried out in a modular fashion, moving from one panel to the next (Fig. 15(a)). Each panel was connected to the next using the finger joint connection. Once rod panels were in place along the vertical and bottom faces of the girder, additional epoxy was applied over the finger joint area to the top of the girders, and the CatStrong TCF 012 was placed atop the CRP 070 using a dry layup process. The same epoxy was applied over the cracks in the abutment, and 13 in. wide CatStrong TCF 012 fabric was centered over the cracks (Fig. 15(b)). Fig. 16 shows the bridge following the completed retrofit. The retrofit underwent periodic inspections in the three years following the construction — no defects were observed.

(a) CRP 070 applied with epoxy

(b) TCF application over abutment crack

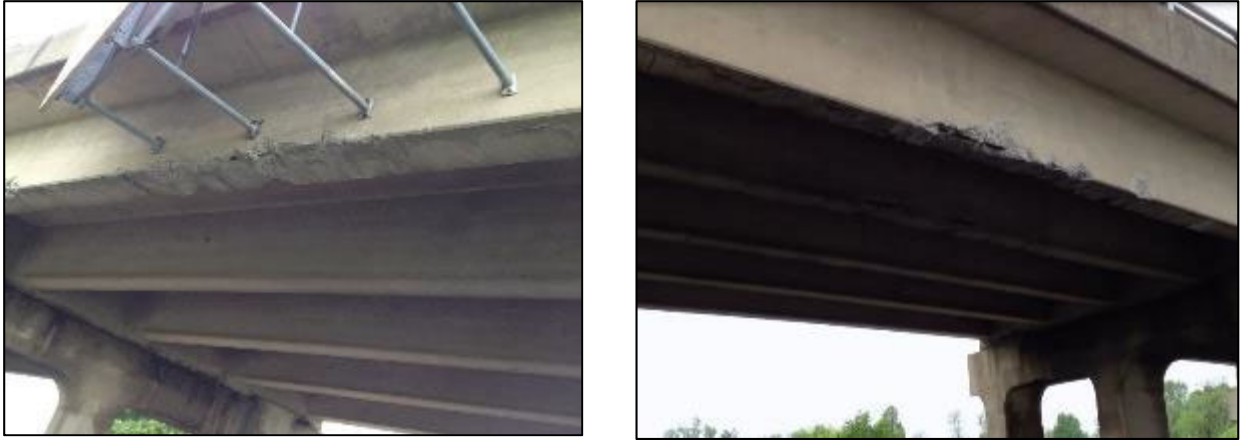
Fig. 19. Damage to concrete girders

The exterior girders on the north side of the southbound and northbound lanes of I-69/Purchase Parkway suffered damage from over-height truck impacts. The impacts damaged rebars and led to concrete spalling. Several of the interior girders also exhibited concrete spalling and minor rebar damage from the over-height impacts.

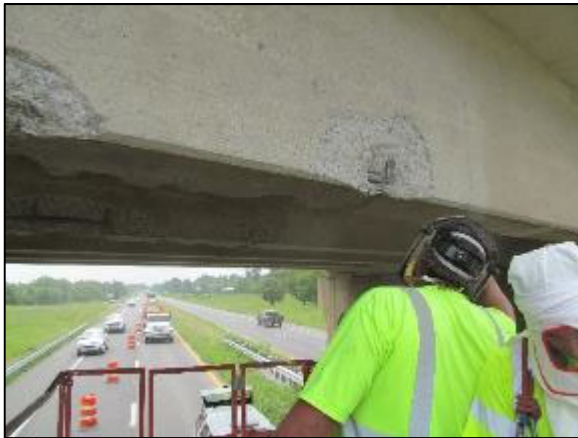
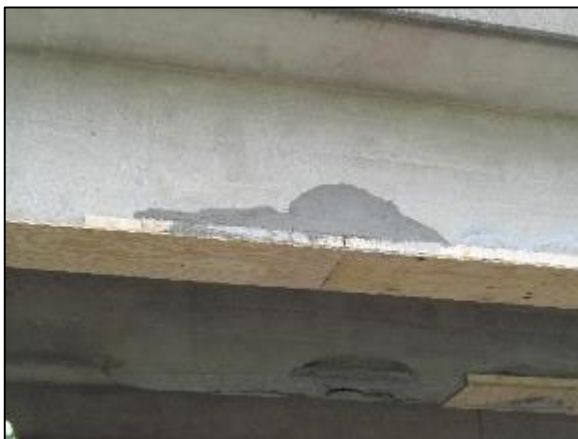
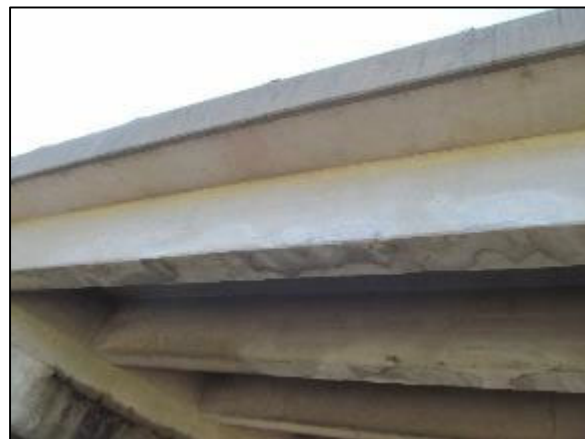
Fig. 21. Repair process of KY 80 over I-69

KYTC District 01 Bridge Maintenance personnel carried out the retrofit in August 2013. One lane of the two-lane north and south bound interstate was closed during construction and the damaged areas were accessed via a scissor lift. Crew members used pneumatic chipping hammers to remove

loose material and expose at least one inch of non-corroded reinforcing steel (Fig. 21(a)). The steel was then sandblasted to remove rust, and a zinc primer was applied with a brush after wiping it with a solvent (Fig. 21(b)). Wooden forms were erected to ensure the repair mortar cured appropriately to provide the original shape of the beam (Fig. 21(c)). The forms were removed once the repair mortar had cured (Fig. 21(d)). A mechanical grinder was used to remove in-plane variations between the repair mortar and pre-existing concrete.

(a) Concrete removed to expose rebar

(c) Wood formwork and repair mortar application

(d) Bridge girder with applied repair mortar

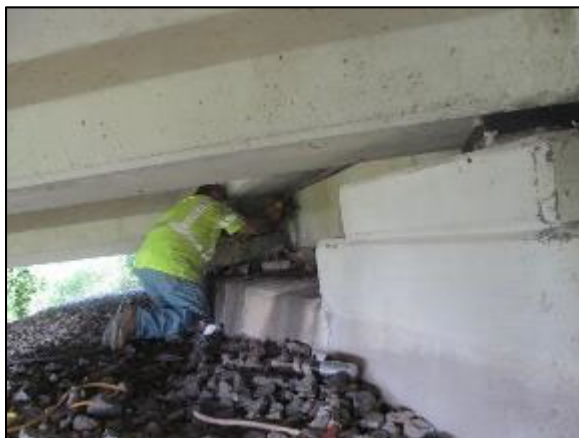
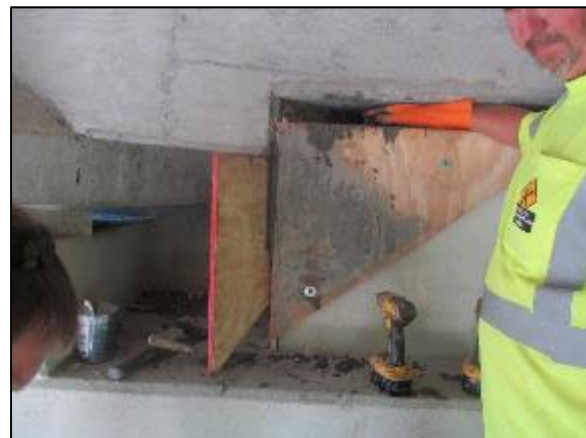
Fig. 29. Beam end repair process

KYTC District 09 Bridge Maintenance Personnel carried out the retrofit during July and August 2014. Loose concrete was removed from the damaged end regions of the PC I-beams over the abutments. Pneumatic chipping hammers were used to remove additional concrete and expose at least one inch of non-corroded prestressing steel. They were cleaned of rust using a mechanical brush (Fig. 29(a)). Wooden forms were erected to ensure the repair mortar cured appropriately to provide the original shape of the beam ends (Fig. 29(b)). Forms were removed once the repair mortar had cured.

(a) Cleaning damaged areas of PC beam ends

(b) Wood formwork and repair mortar application

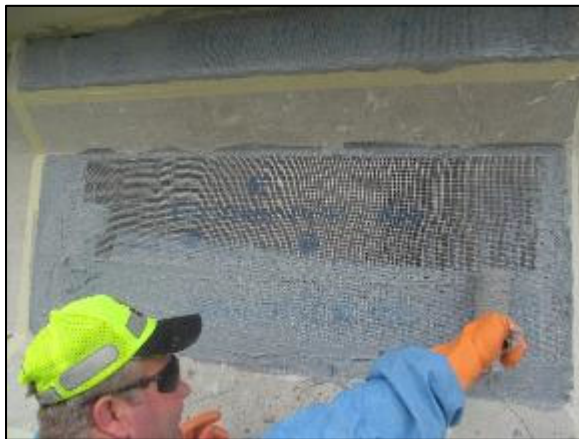
Fig. 30. CRP and TCF application on KY 11 over CSX Railroad and Strodes Run Pike

The cracks at the PC I-girder ends were too small to be injected with crack filling epoxy. The ends were blast cleaned using a pressure washer and, once dried, the CatStrong UCF 055 and/or TCF 012 application was carried out. A two-part saturating epoxy was used to impregnate the fabric prior to the application. Once the UCF 055 was applied, the TCF 012 U-wraps were placed over them. Small strips of UCF 055 were used as anchor strips for the TCF 012 U-wraps. For several girders on which the cracks were quite small, the CatStrong TCF 012 U-wraps were the primary strengthening material. After the epoxy had cured, a UV protective coating was applied over the retrofit areas on the exterior girders.

(a) Modular CRP application process

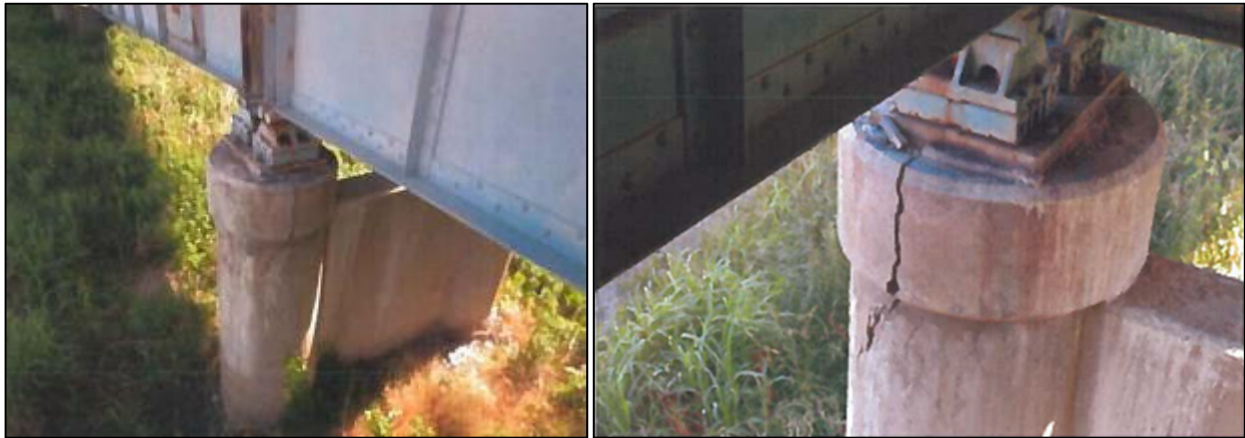
Fig. 34. Typical damage to pier cap in US 60 bridge over Cumberland River

The pier cap on one of the approach span piers had a large vertical crack (Fig. 34). The crack originated under the bearing plate, propagated down the pier cap, and extended into the pier column. Several smaller cracks were seen on the opposite side of the pier cap.

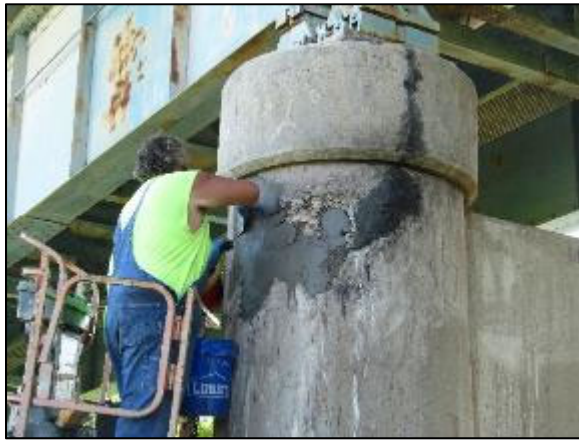
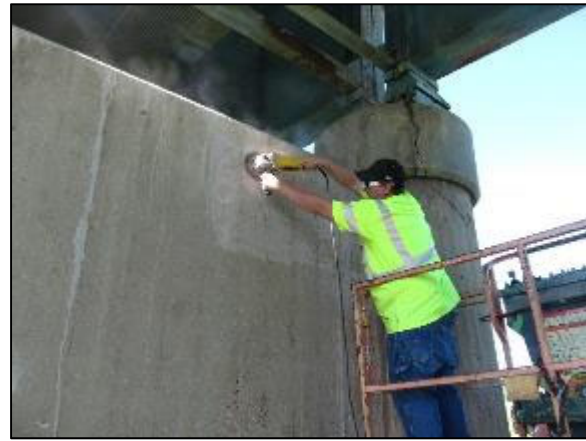
Fig. 36. Repair process of KY 60 over Cumberland River

The retrofit was carried out by the KYTC District 01 bridge maintenance crew in April 2016. Loose concrete was removed and the crack filled prior to the CatStrong carbon fabric application. The damaged area was filled with repair mortar to return the column to its original shape (Fig. 36(a)). Once cured, the repair mortar was ground to remove in-plane variations between the repair mortar and pre-existing concrete. In addition, the CatStrong fabric bond surfaces were cleaned using a mechanical grinder to provide a good bond surface.

(a) Repair mortar application

(b) Surface preparation for CatStrong UCF 115

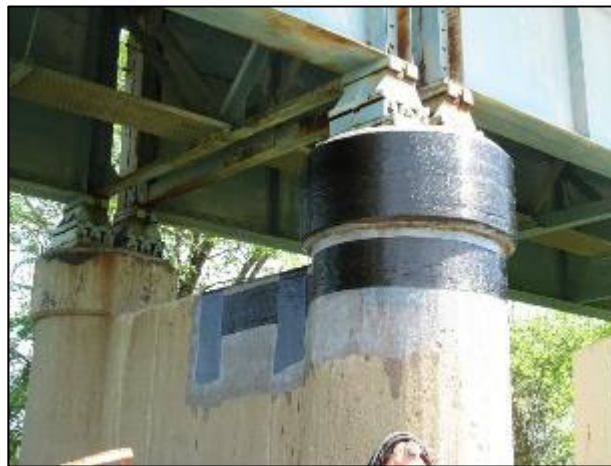
Fig. 38. Completed repairs to US 60 over Cumberland River bridge pier

Twelve inch wide CatStrong UCF 023 anchor strips were applied over the CatStrong UCF 115 carbon fabric at the termination point as well as the transition point between the Pier column and Pier wall. The completed retrofit following the application of the UCF 023 anchor strips is shown in Fig. 38.

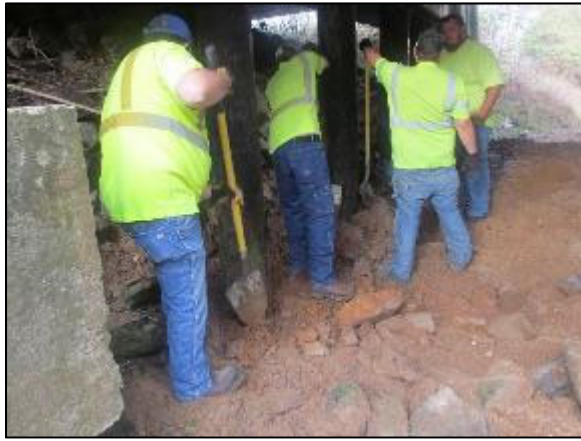
KYTC District 01 Bridge Maintenance personnel carried out the retrofit in November 2015. Earth surrounding the base of the damaged timber was cleared with shovels (Fig. 42(a)). Spacers were attached into the timber pile (Fig. 42(b)) to maintain 2 in. of spacing between the timber pile surface and the CatStrong TCW 012 to accommodate the epoxy mortar. As seen in Fig. 42(c), the CatStrong TCW 012 overlap was coated in a structural epoxy, wrapped around the spacers, and secured with adhesive tape. Epoxy mortar was then mixed and placed between the timber pile and the TCW 012.

(a) Clearing area around base of timber piles

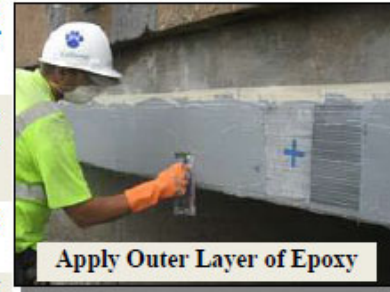
- 3.2 Apply outer layer of epoxy to CatStrong panel and smooth paste along entirety of panel. Remove any excess adhesive.

Apply Outer Layer of Epoxy

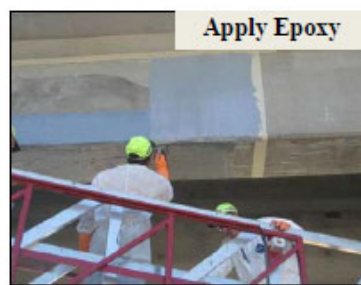
Step 3: Application of CatStrong TCF
